RESEARCH MEMORANDUM

FLYING QUALITIES OF A HIGH-PERFORMANCE

PERSONAL-OWNER AIRPLANE

By James J. Adams and James B. Whitten

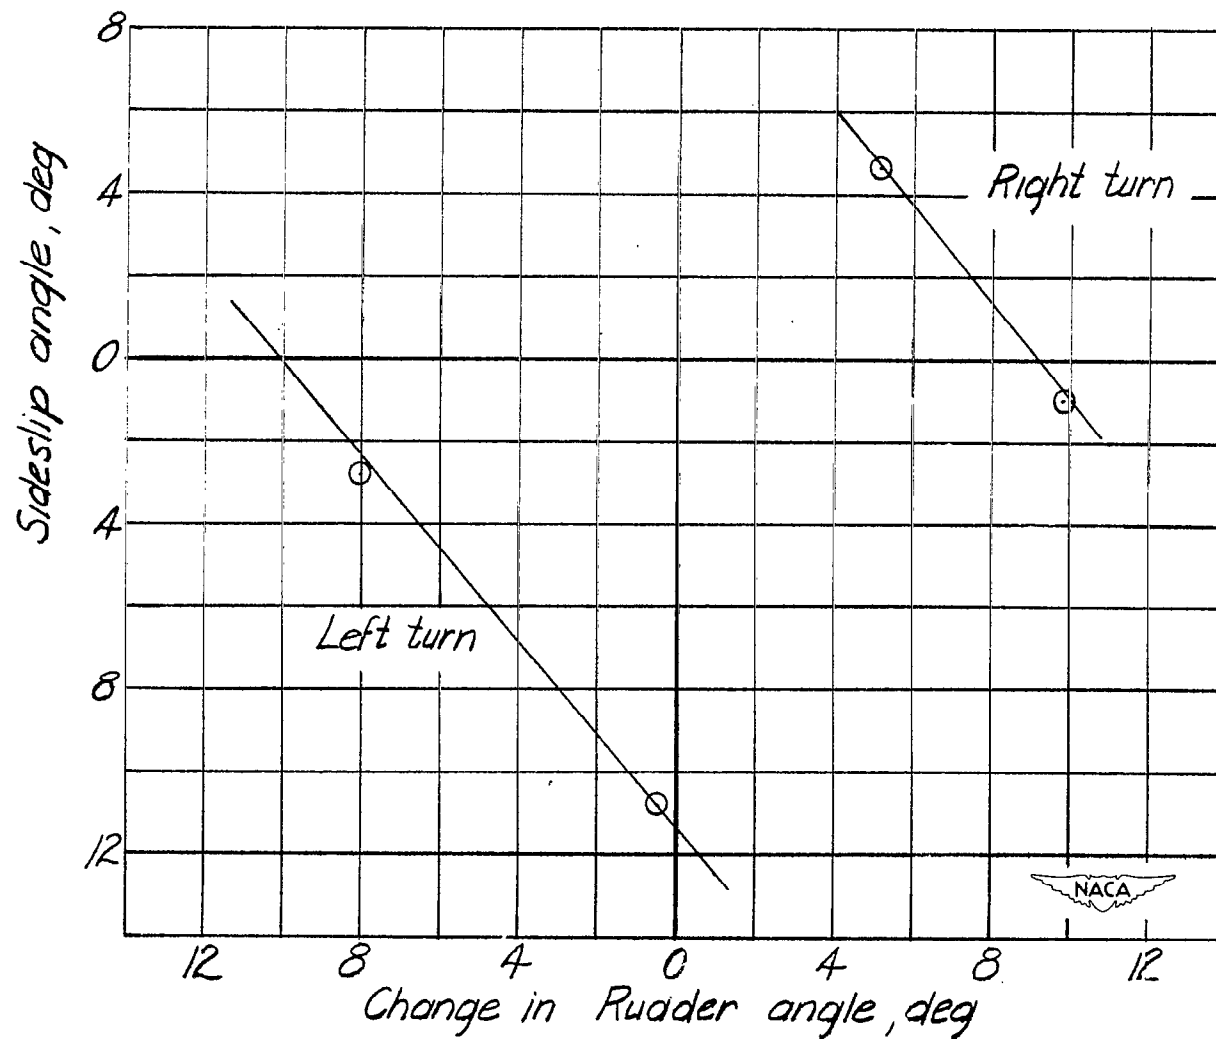
Figure 19.- Plot of maximum sideslip reached in one-half aileron rolls made with varying amounts of rudder angle at 66 miles per hour, power on, clean condition. Beech B-35 Bonanza airplane.

Rudder control.- Limited tests of the rudder required to overcome aileron yawing moment were conducted, and the results are shown in figure 19. Rolls into turns at an airspeed of 65 miles per hour in the power-on, clean condition using one-half ailerons were performed using various amounts of rudder. By plotting the sideslip angle against rudder deflection it is possible to determine the amount of rudder required to obtain a coordinated turn with zero sideslip. Similar tests were run with the rudder free, so that the only rudder control obtained was produced by the aileron-rudder coordinating spring. The results showed that the coordinating spring will supply on the order of one-tenth of the rudder required for one-half full-deflection aileron rolls. The term "coordinating spring" is therefore somewhat inappropriate inasmuch as a much stiffer spring would be required to provide proper control coordination in aileron rolls. Probably the main advantage of this spring is the previously noted increase in stick-free dihedral effect in the power-on, flaps-down condition.

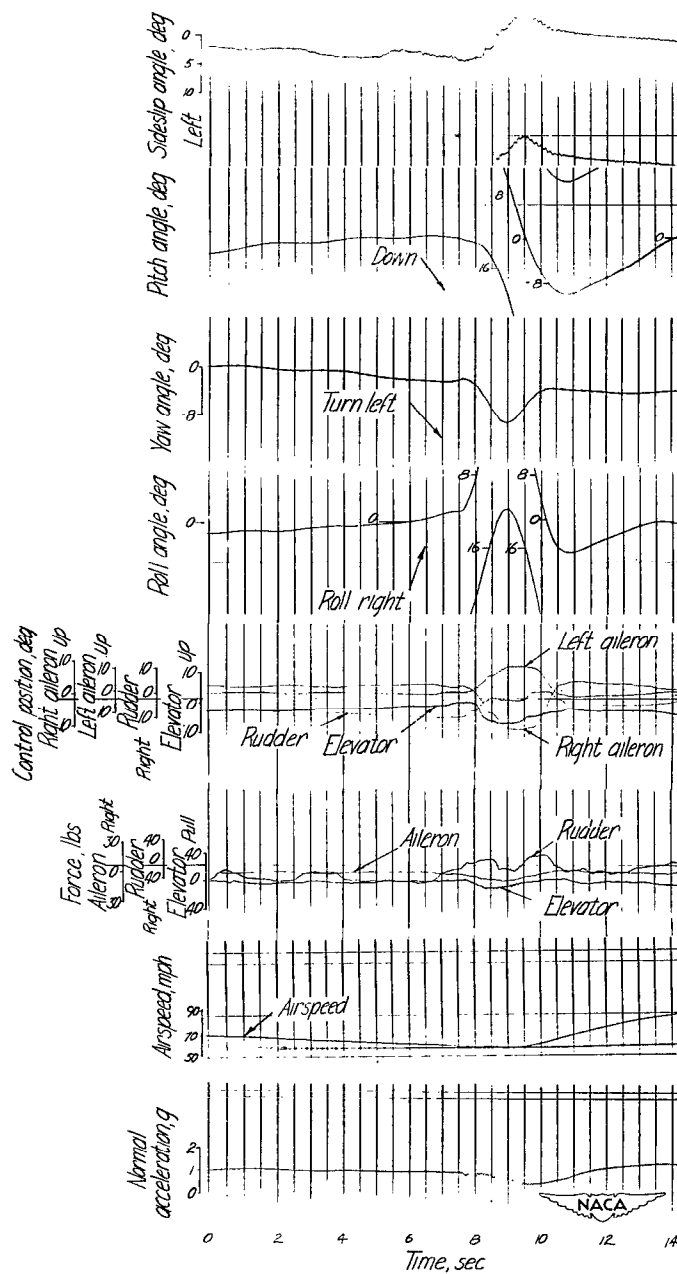
(a) Power on (22 in. Hg at 2050 rpm); normal recovery; clean condition.

Figure 20.- Time histories of stalls in the Beech B-35 Bonanza airplane.
Center of gravity = 29.3 percent mean aerodynamic chord;
weight = 2500 pounds.

Figure 20(a) is the time history of a stall performed in the power-on, clean condition with the center of gravity located at 29.3 percent of the mean aerodynamic chord. This stall, and all of the stalls presented in this paper, were initiated by slowly decreasing the airspeed while holding the wings level. Figure 20(a) shows the history of a stall followed by a normal recovery. Figures 20(b) and 20(c) are stalls done in the same condition and in the same manner with the exceptions that figure 20(b) is with power off and figure 20(c) is in the landing condition.

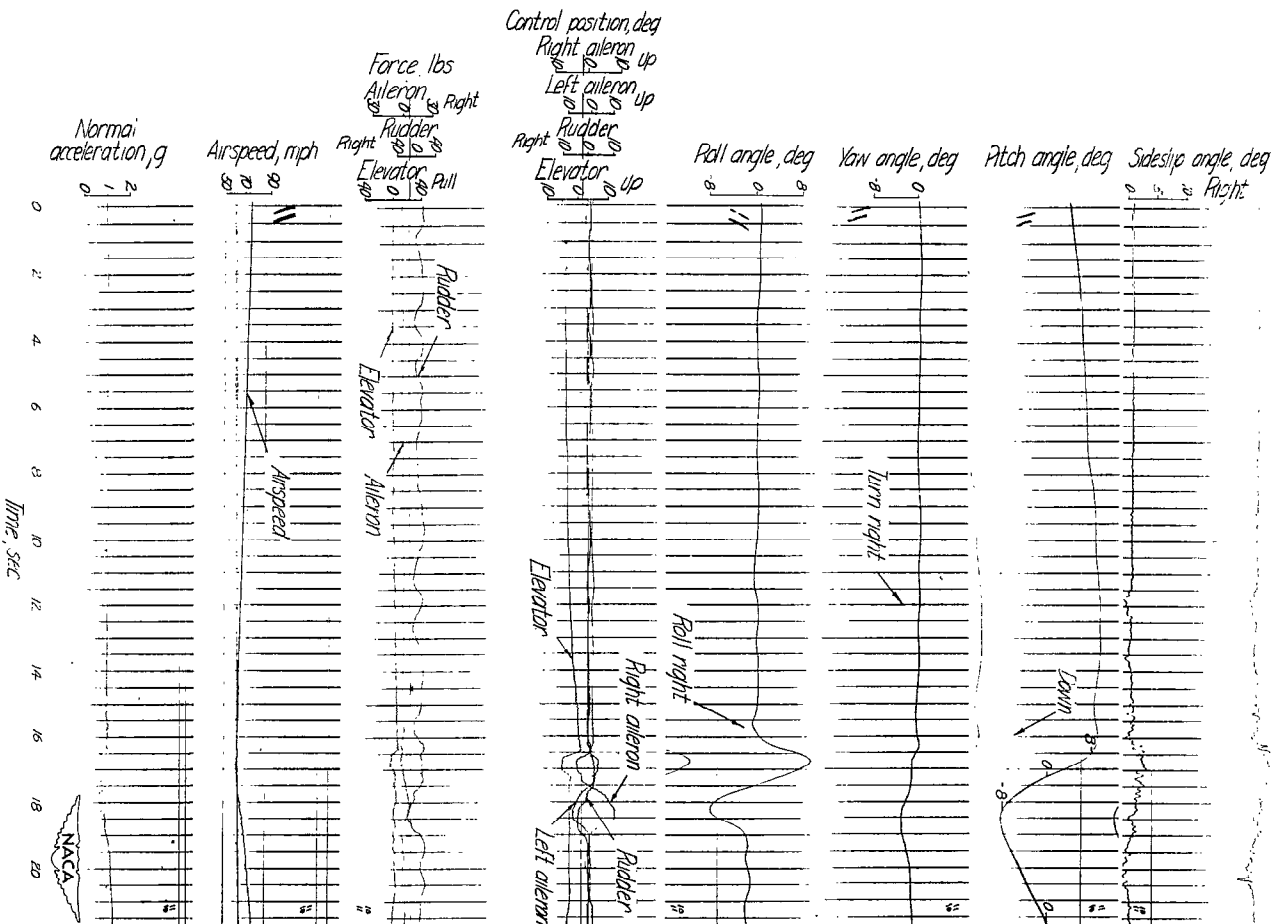
(b) Power off; clean condition; normal recovery.

Figure 20.- Continued.

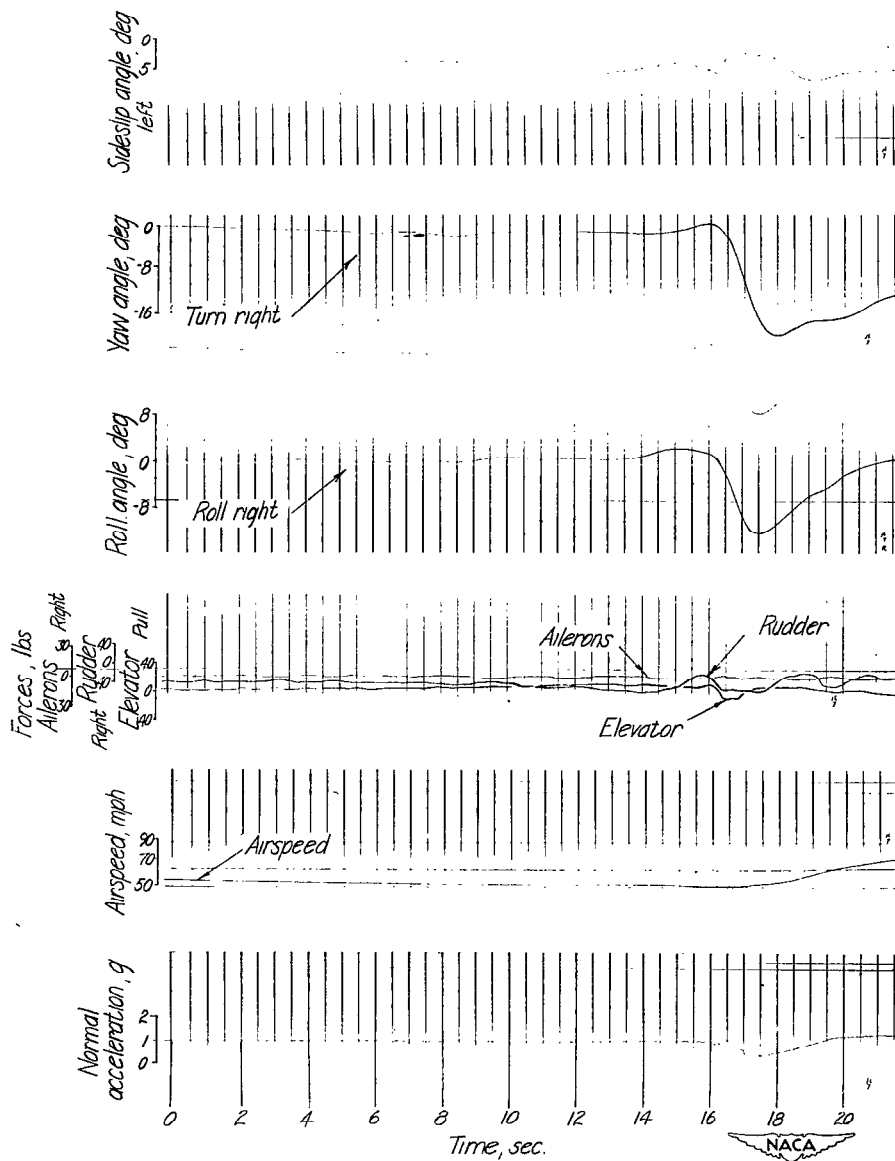
(c) Power on; landing condition; normal recovery.

Figure 20.- Continued.

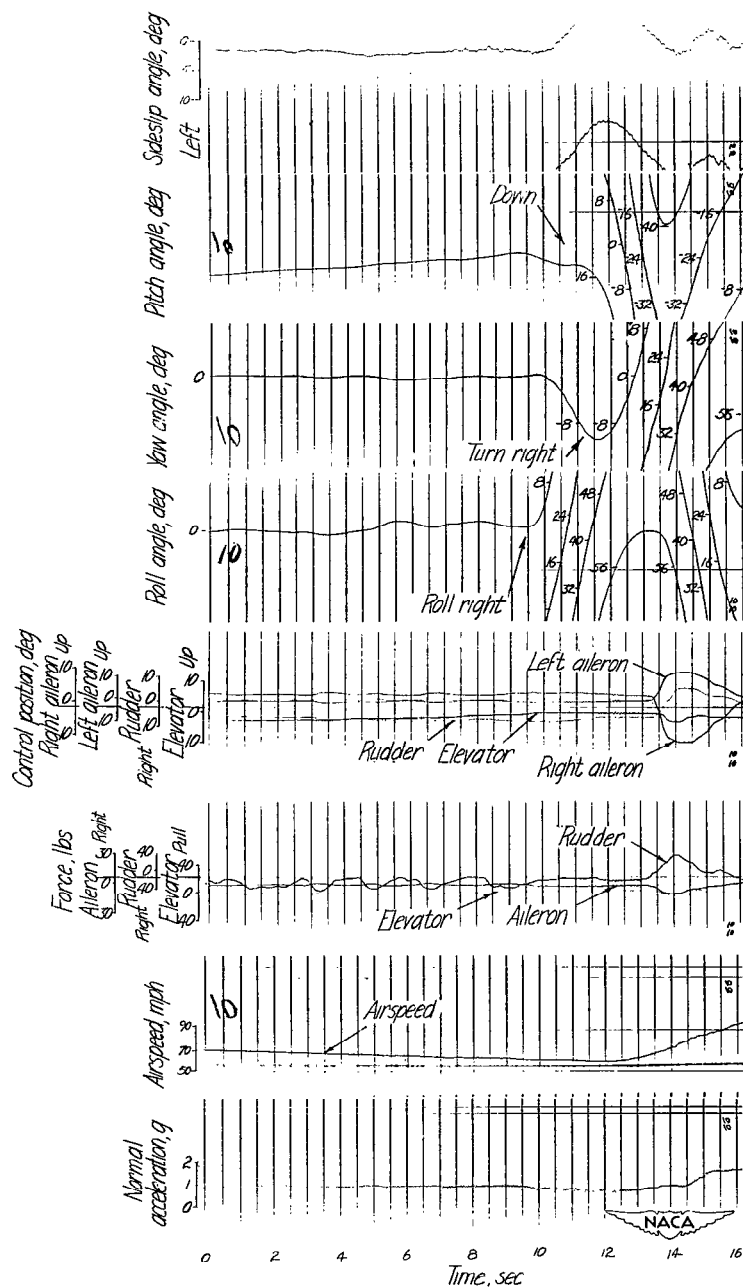
(d) Power on; clean condition; controls held fixed.

Figure 20.- Continued.

Figures 20(d) and 20(e) are time histories of stalls in which the controls were fixed as long as possible during the rolling motion. These stalls were made in the same conditions mentioned previously. The airplane started the stalls with a small amount of left sideslip. The initial roll-off was to the right. This roll would continue to the right until the airplane was slipping to the right. Then the airplane reversed its direction of roll. The roll to the left continued until the airplane was slipping to the left again. The pilot stopped the action after 1 cycle because the airplane had reached an undesirable attitude. Recovery was made by applying down elevator.

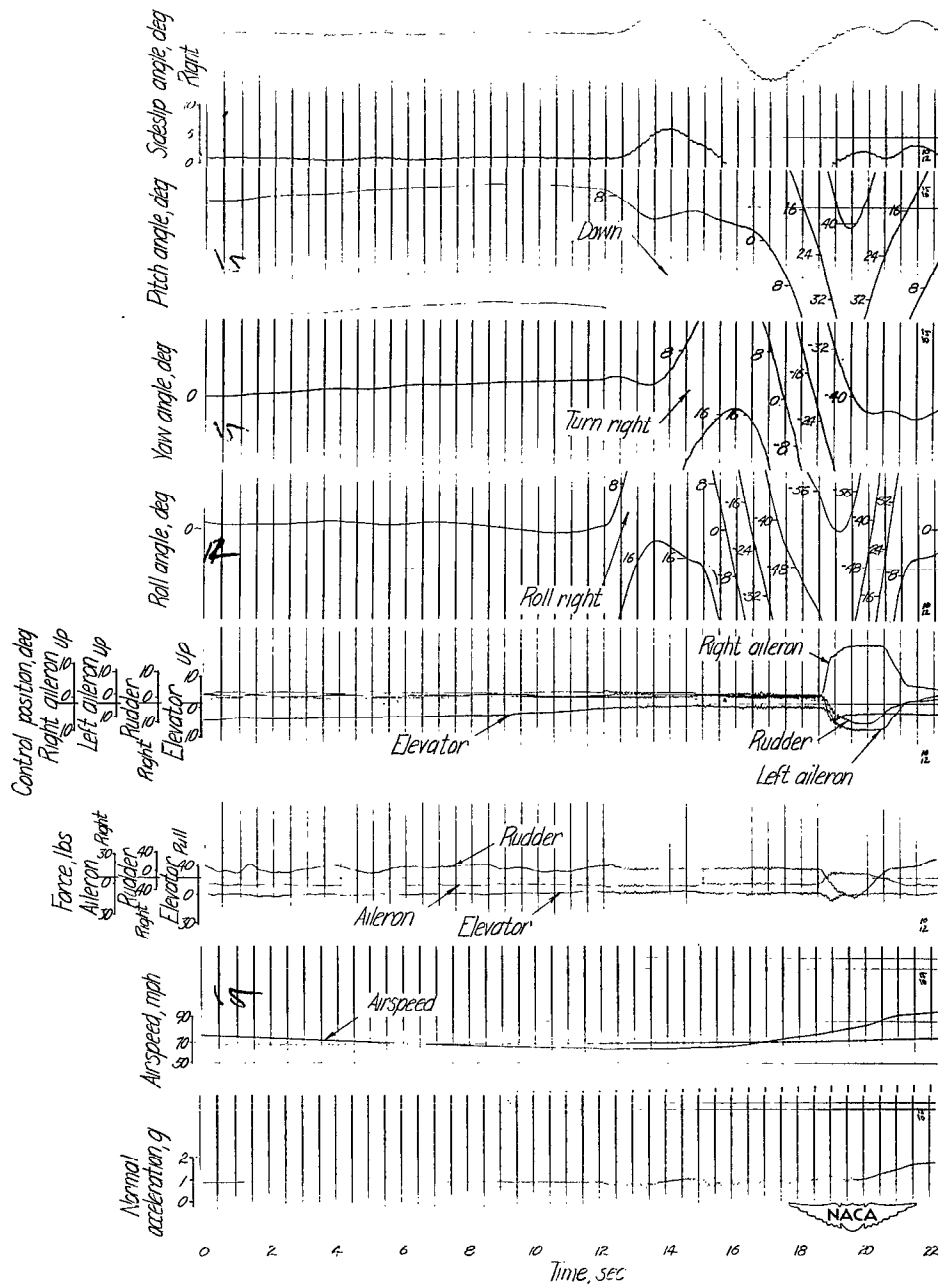
(e) Power off; clean condition; controls held fixed.

Figure 20.- Continued.

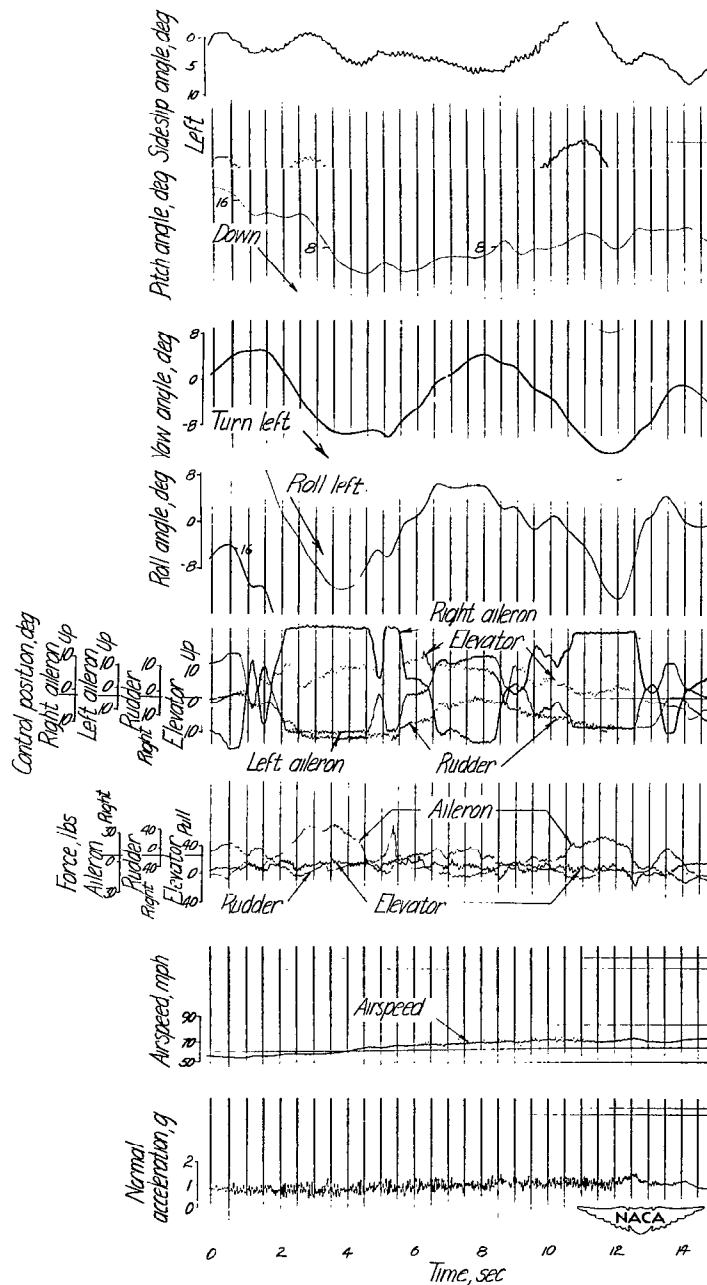
(f) Power on; clean condition; airplane controlled beyond the stall.

Figure 20.- Continued.

Stalls were also made in which it was attempted to prolong the stall by holding full-up elevator. Time histories of this maneuver in the clean condition, both power on and power off, are shown in figures 20(f) and 20(g) and in the landing condition, power on, in figure 20(h). The center of gravity was located at 29.3 percent mean aerodynamic chord as before. In the clean condition it was found that the roll-off could be controlled by use of the aileron and rudder, or by use of the ailerons alone. Attempts to control the roll-off by use of the rudder alone were unsuccessful. In the landing condition, the roll-off was more violent than in the clean condition so that it was impossible to fly steadily in the stalled attitude. Recovery was made by applying down elevator.

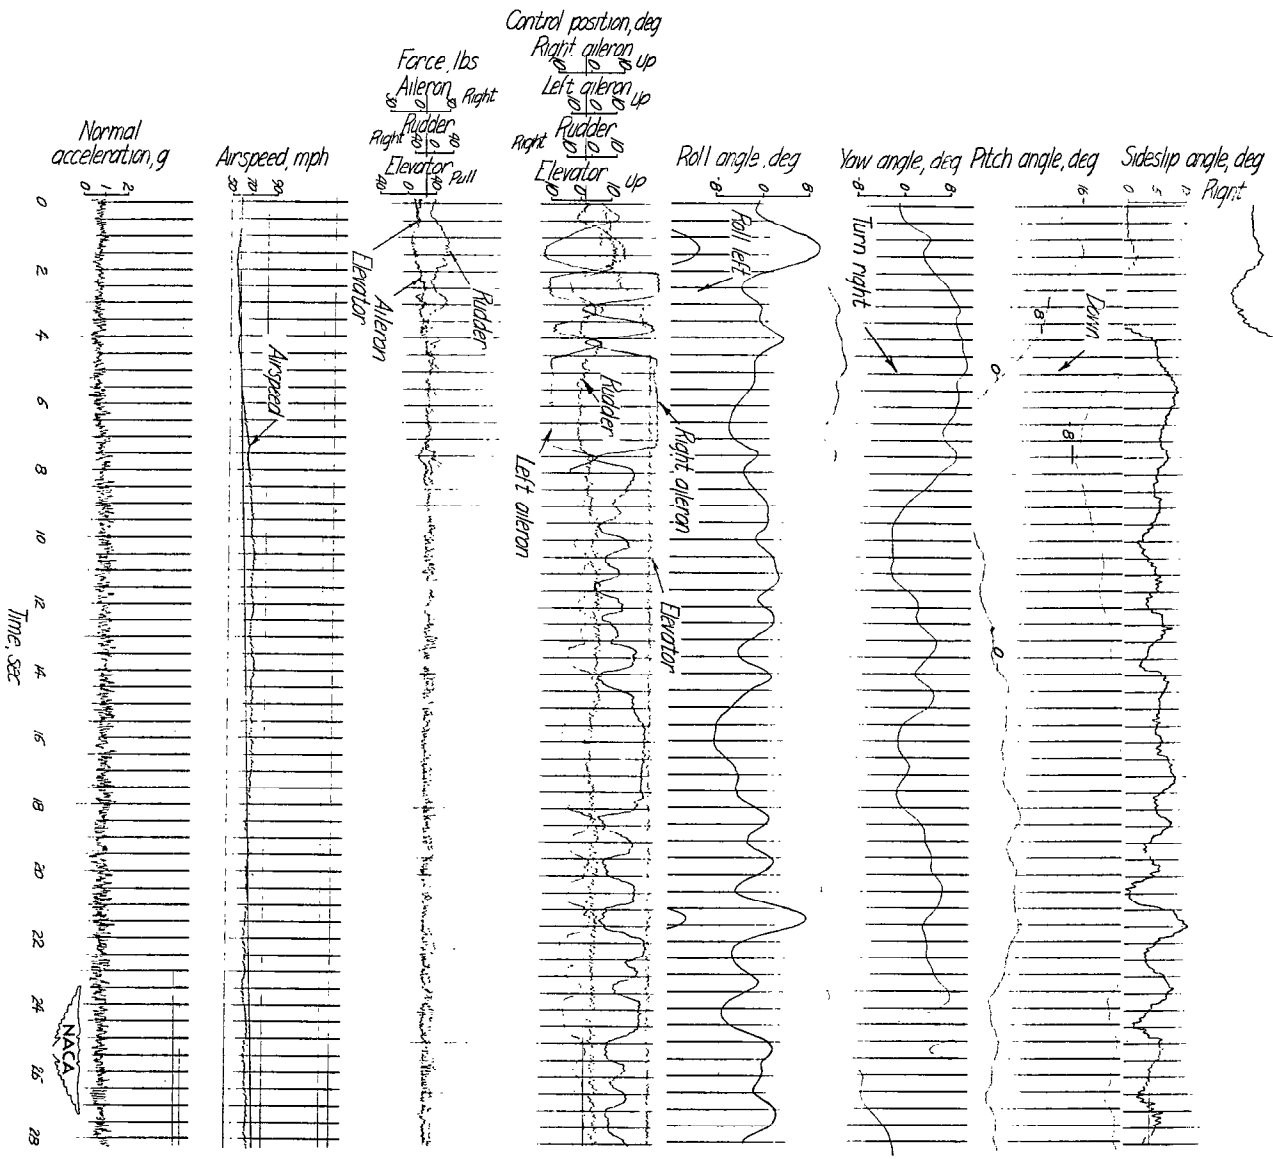
(g) Power off; clean condition; airplane controlled beyond the stall.

Figure 20.- Continued.

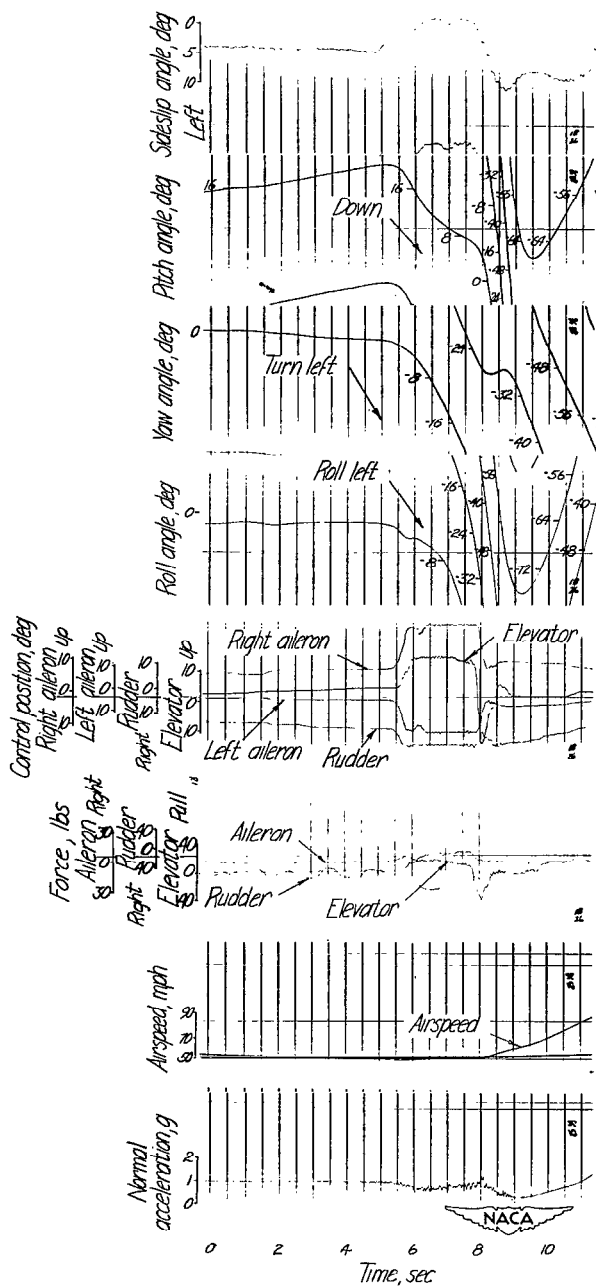
(h) Power on; landing condition; attempt to control the airplane beyond the stall.

Figure 20.- Concluded.

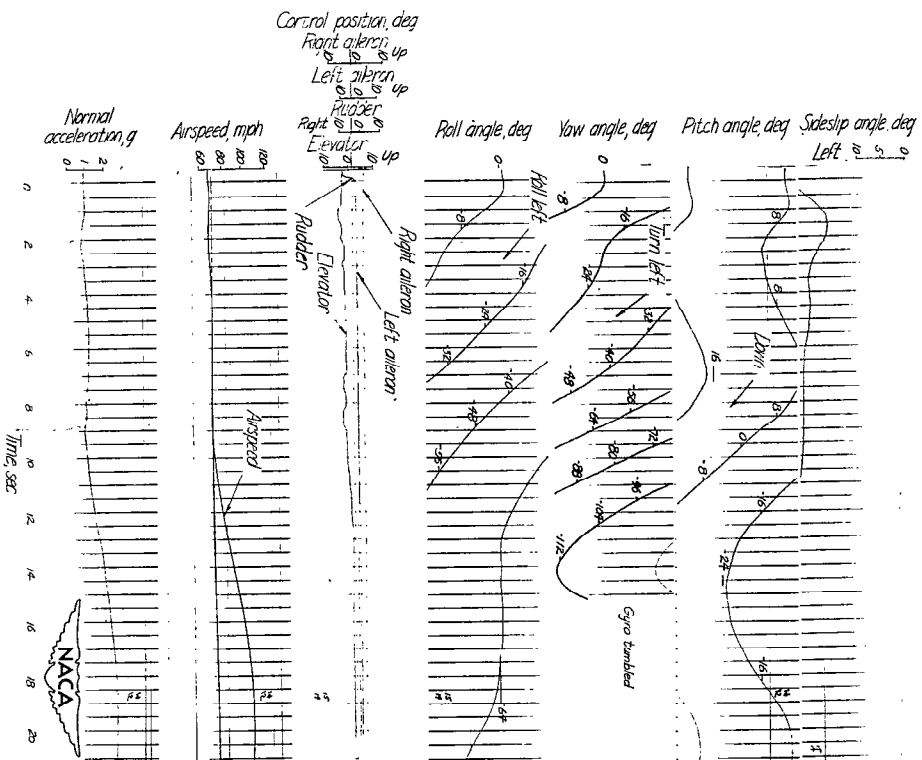
(a) Low speed.

Figure 21.- Time histories of the spiral divergence of the Beech B-35 Bonanza airplane. The records were started during straight and level flight at the time that the controls were released. The airspeed was controlled by moving the control wheel yoke.

Figure 21(a) is a time history of the spiral divergence which started at 68 miles per hour, and during which the airspeed was held constant. Since the airplane has no adjustable rudder trim device, the rudder moved to an out-of-trim position when the controls were released. In this case the rudder moved 8° to the left. While the airspeed was held constant the airplane diverged rapidly to the left. When the controls were released at cruising speed, figure 21(b), the rudder moved approximately 1° to the left and the airplane diverged slowly to the left. At the high speed, 180 miles per hour, the airplane was in trim with the controls free, and the divergence disappeared, figure 21(c). Only a steady turn was recorded.

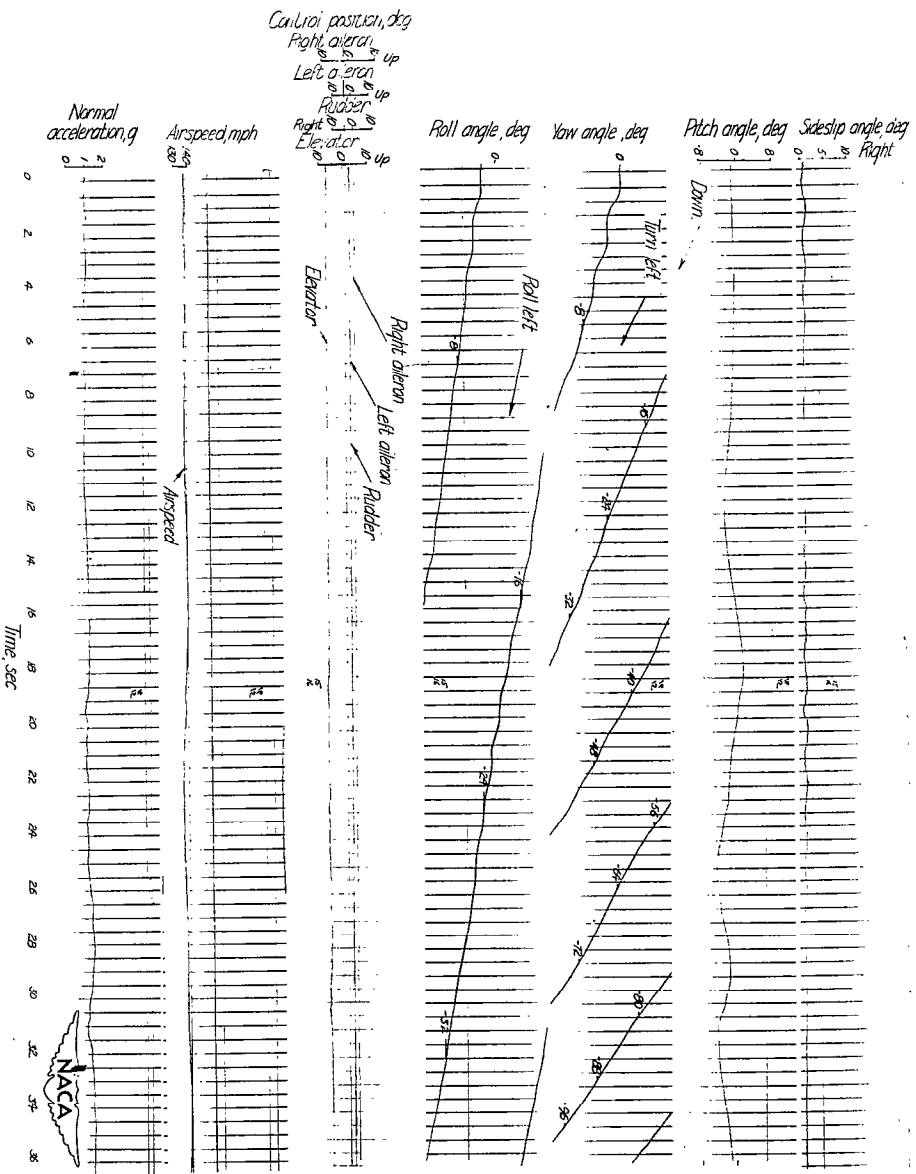
(b) Cruising speed.

Figure 21.- Continued.

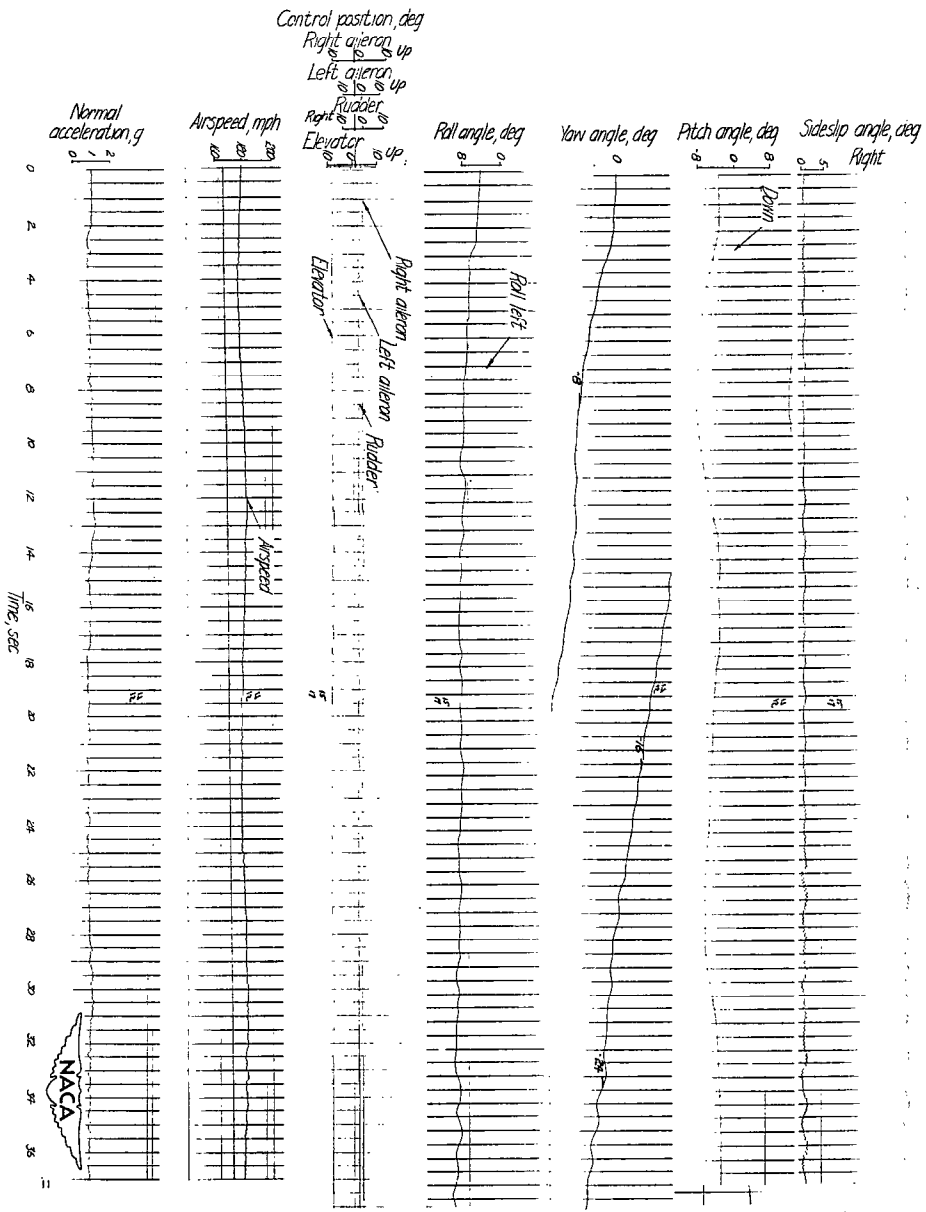
(c) High speed.

Figure 21.- Concluded.

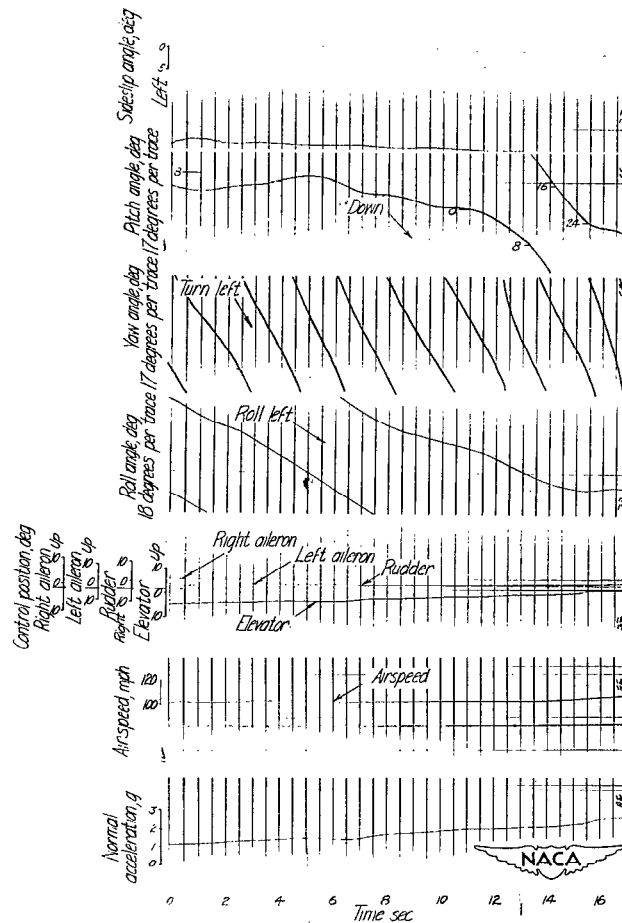
(a) Low speed. This maneuver was started at 72 miles per hour, but the record did not start until a speed of 102 miles per hour was reached.

Figure 22.- Time histories of the spiral divergence of the Beech B-35 Bonanza airplane. The records were started during straight and level flight at the time when all the controls were released. No attempt was made to control the airspeed.

When the airspeed was allowed to increase during the tests, the divergence was more rapid. In the first case, figure 22(a), the controls were released at 70 miles per hour. From the incomplete record of this test it can be seen that the airspeed reached a constant value of 100 miles per hour, but that the normal acceleration was increasing steadily and reached approximately $2\frac{1}{2}g$ before the records were turned off. When the controls were released at 100 miles per hour, figure 22(b), the airspeed increased to 140 miles per hour in 36 seconds. The normal acceleration reached approximately $1\frac{3}{4}g$ by that time. The first case of divergence to the right was encountered when the controls were released at 180 miles per hour and the airspeed allowed to increase, figure 22(c). The airspeed increased to 195 miles per hour, accompanied by a steady increase in normal acceleration, before the test was terminated.

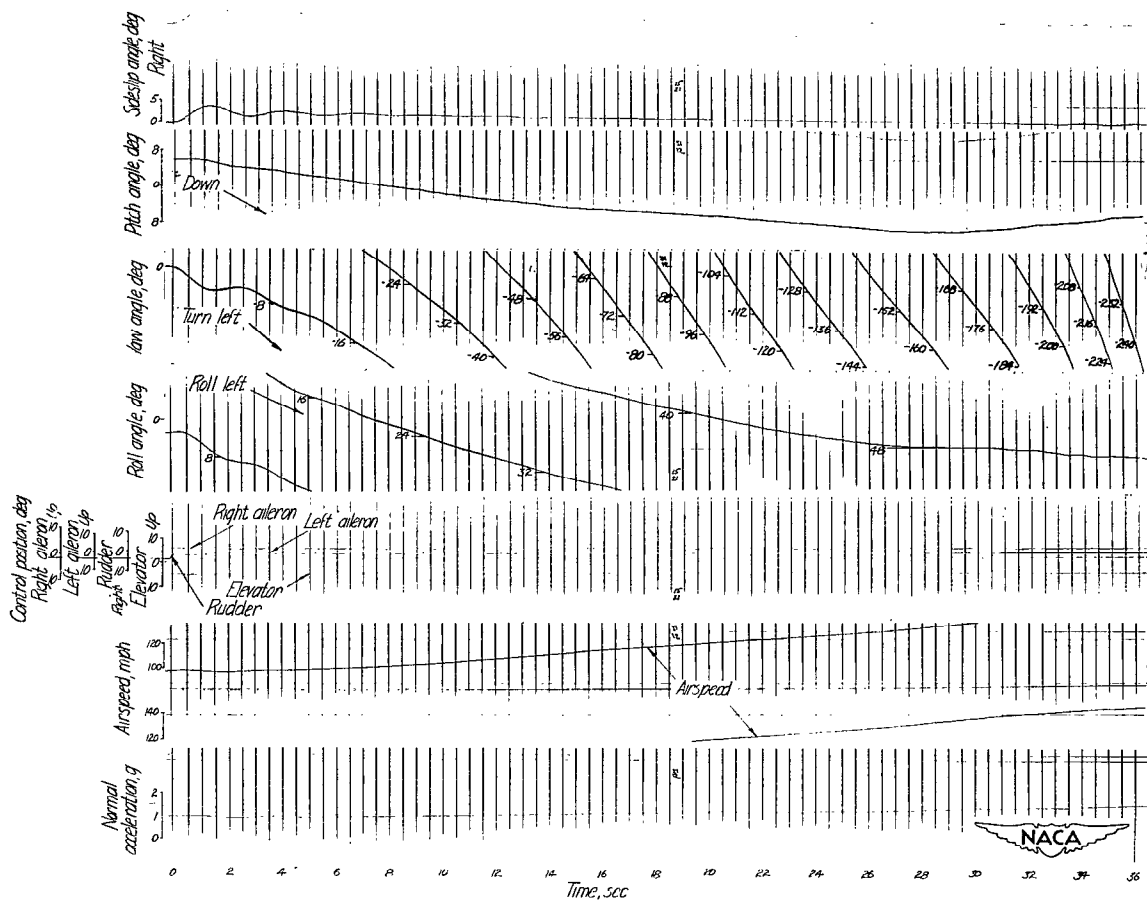
(b) Low speed.

Figure 22.- Continued.

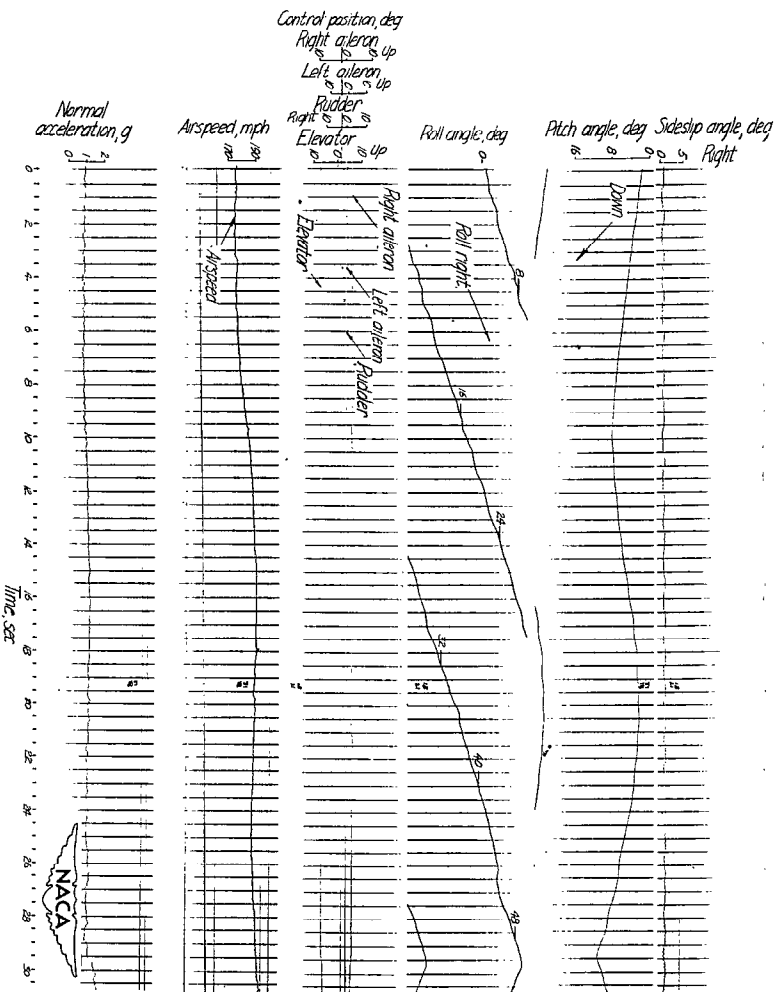
(c) High speed. Yaw angle not available.

Figure 22.- Concluded.

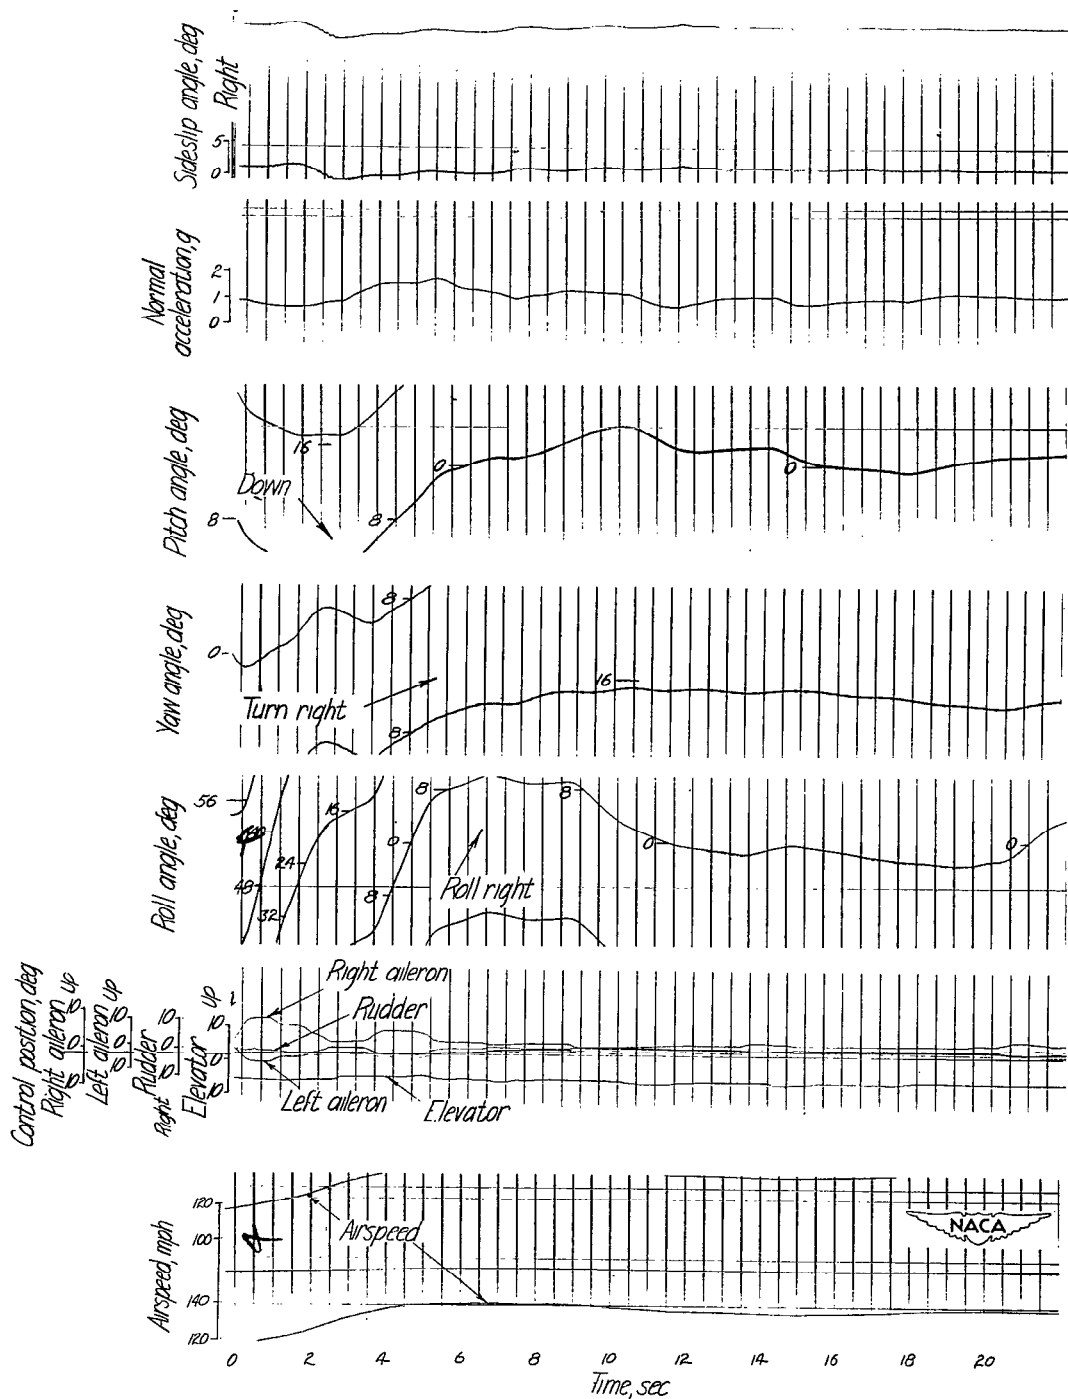
(a) Recovery from a left diving turn.

Figure 23.- Time histories of recoveries from large displacements while flying under a hood. Beech B-35 Bonanza airplane.

From figure 23 it can be seen that it generally took the pilot 0.5 second to start correcting the attitude of the airplane. In all cases he was able to return the airplane to level flight with very little control movement without the airplane exceeding the airspeed or acceleration limits. It should be noted that the pilot who made these recoveries was an experienced instrument pilot.

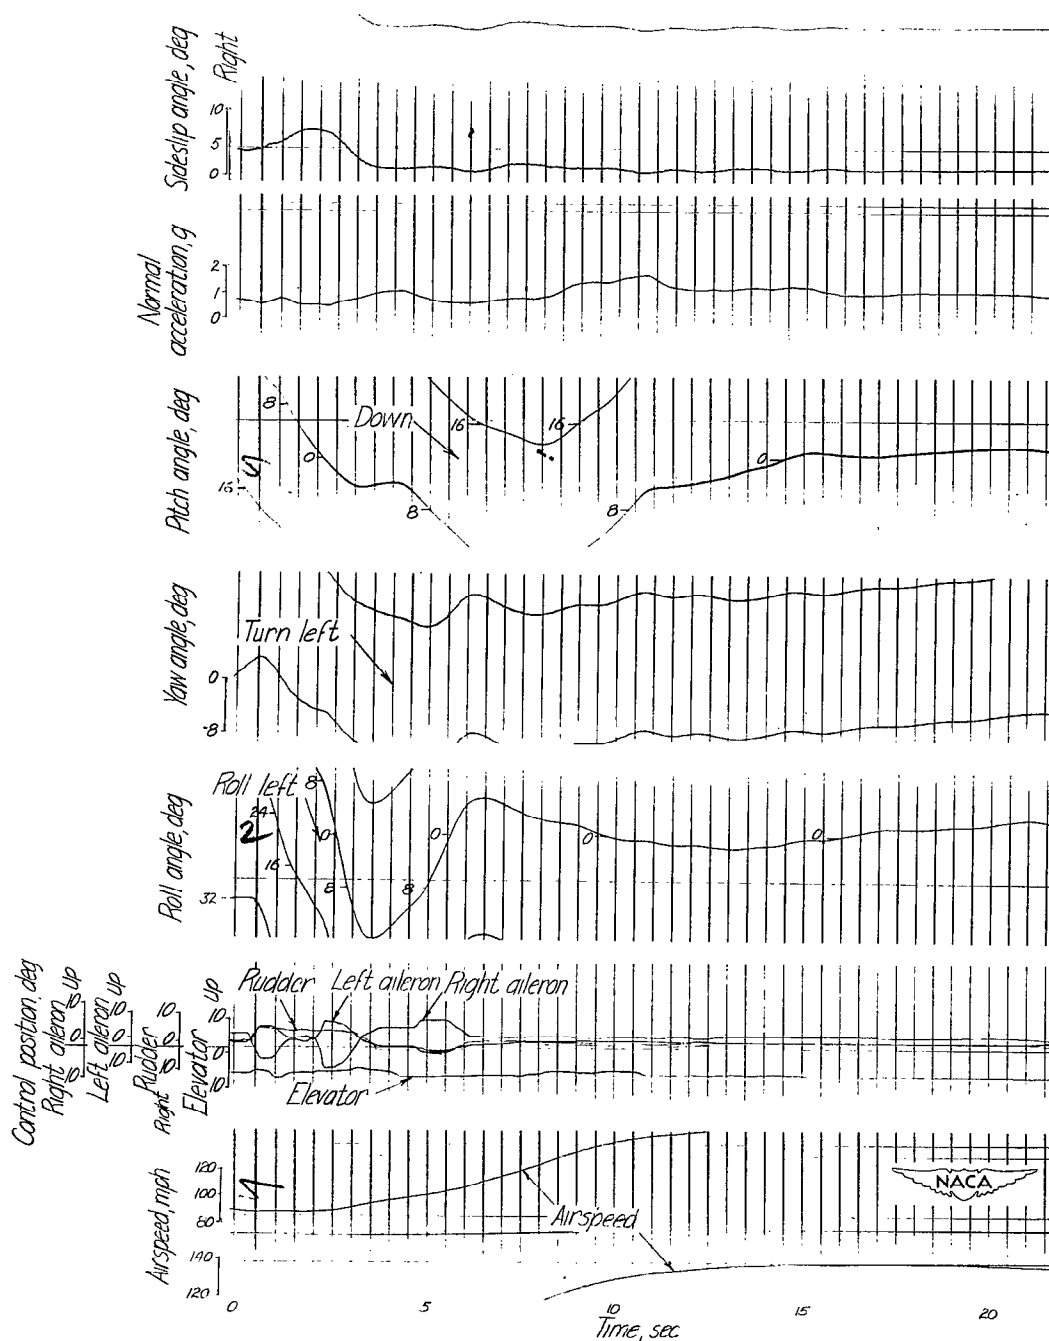
(b) Recovery from a climbing; right turn.

Figure 23.- Concluded.

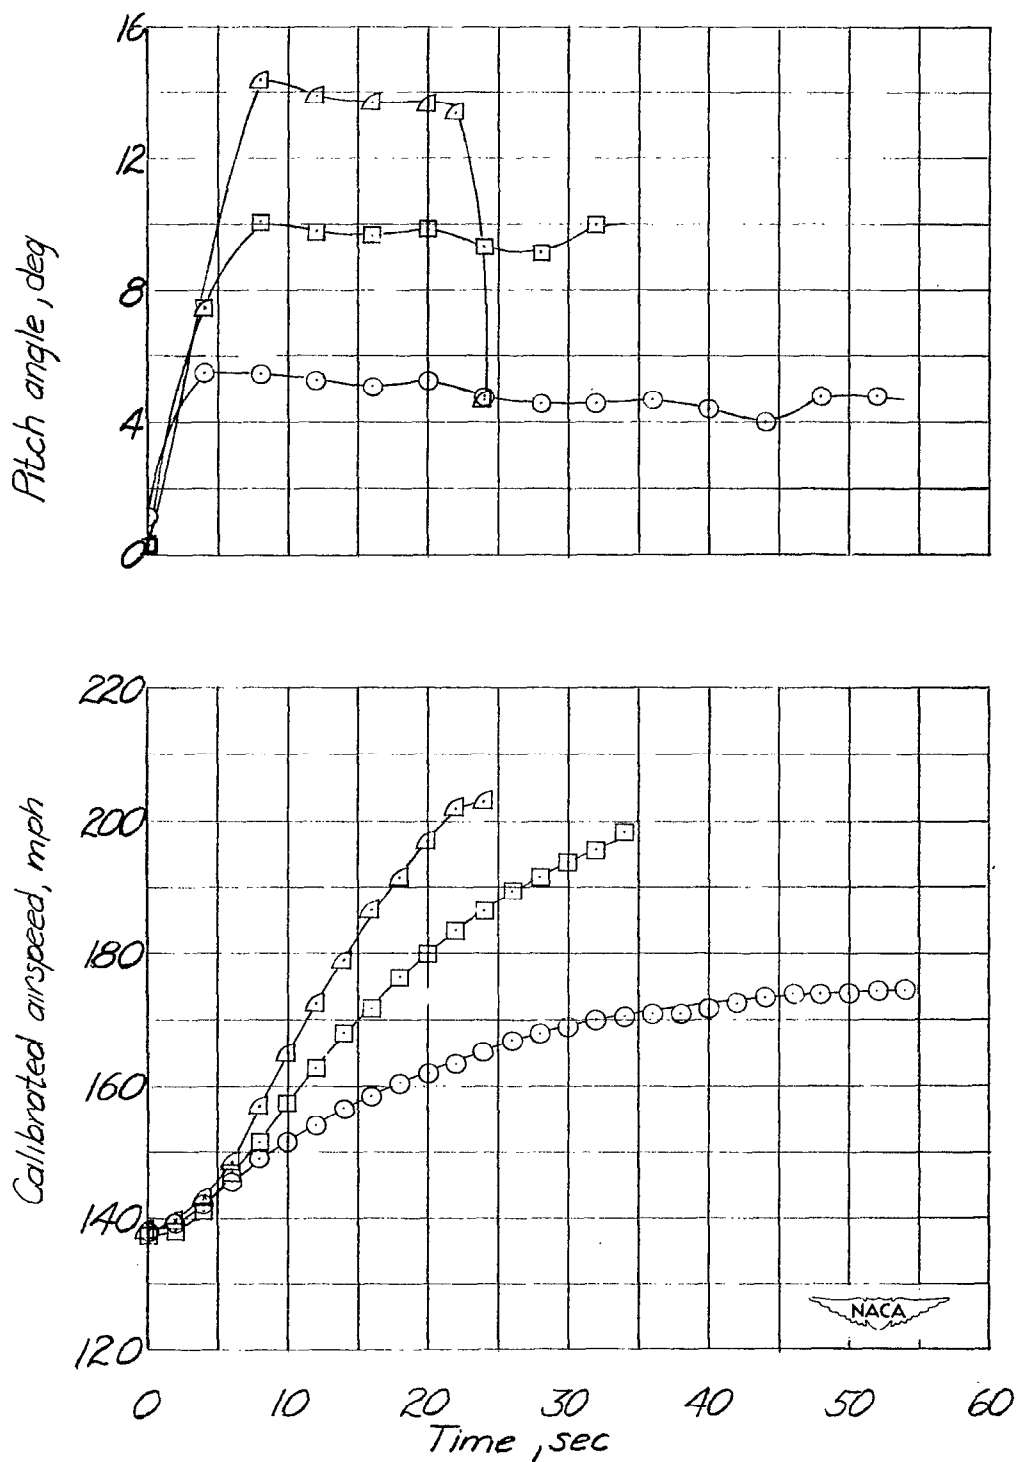
Figure 24.- Time histories of the airspeed in several shallow dives at constant power in the Beech B-35 Bonanza airplane.

Speed increase.- Examples of the speed increase of the airplane in steady dives are shown in figure 24. These runs were started with a power setting for level flight at 140 miles per hour. The power was held constant throughout the test. The airplane was placed in a dive and held at the same pitch angle until the airplane reached its terminal velocity or reached the maximum allowable velocity. The initial rate of increase in the velocity is a function of gravity alone. The drag of the airplane determines the terminal velocity corresponding to the angle of the dive. Figure 24 shows that when the airplane was pitched down 5° the velocity exponentially approached 174 miles per hour. In the 10° pitch-down dive the airplane exceeded its maximum allowable velocity of 202 miles per hour in 40 seconds; in the 14° dive the maximum allowable velocity was exceeded in 22 seconds.
